Applying High-Throughput Analysis to Biofilms

Part I – Dentistry Mystery

Part II – Method of Analysis

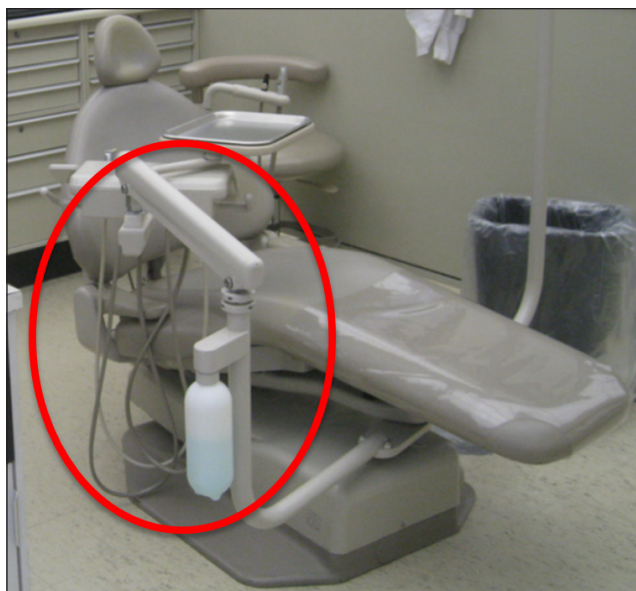
Figure 1. Standard dental chair with the DUWL system circled. The water bottle is often times filled with water from the sink, coming from the municipal water supply. Credit: Andrew Horne, <https://commons.wikimedia.org/wiki/File:Dental_Chair_UMSOD.jpg>.

Dental-unit waterlines (DUWLs) are flexible pieces of plastic tubing that supply water to the different handpieces used in a dental office. Studies have shown that insufficient means to drain the waterlines makes for an ideal aquatic environment to harbor bacterial biofilms, some of which serve as an oasis for pathogens (Walker *et al.*, 2000). *Legionella pneumophila*, *Mycobacterium* spp., *Candida* spp., and *Pseudomonas* spp. are among the bacterial species found within DUWLs in regular practice. Although DUWLs have been identified as a reoccurring source of contamination, they are not the only way in which harmful microbes can be introduced into a dental office; it is also worth noting that cross-contamination can happen in a dental laboratory, such as when polishing dentures. "More than 60% of the prostheses delivered to clinics from laboratories are contaminated with pathogenic microorganisms...originating in the oral cavity of other patients" (Agostinho *et al.*, 2004). Such evidence indicates that there is still work to be done to completely eliminate the presence of unwanted bacteria in the realm of dentistry. Nonetheless, experiments are in progress to aid this cause.

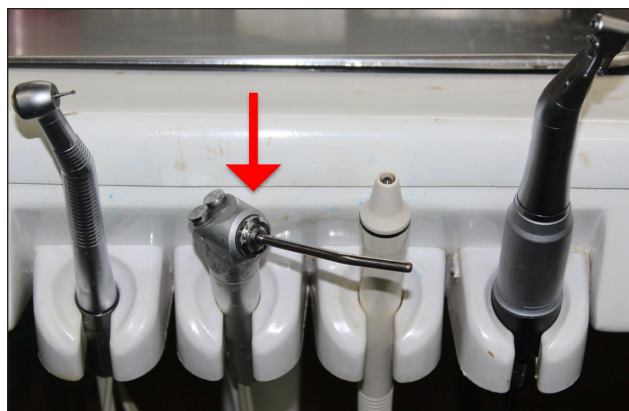
Figure 2. The arrow indicates a possible source of contact with water from DUWLs. A hose connects the piece indicated to the water bottle shown in Figure 1 and a button is pressed to release water through the water tip. Credit: PD, <<https://pixabay.com/en/dental-chair-dentist-clinic-1491237/>>.
